FLOOD PLAIN INFORMATION

QUINNIPIAC RIVER

SOUTHINGTON

PREPARED FOR
THE TOWN OF SOUTHLINGTON, CONNECTICUT
BY
DEPARTMENT OF THE ARMY
NEW ENGLAND DIVISION, CORPS OF ENGINEERS
WALTHAM, MASSACHUSETTS
JANUARY 1970

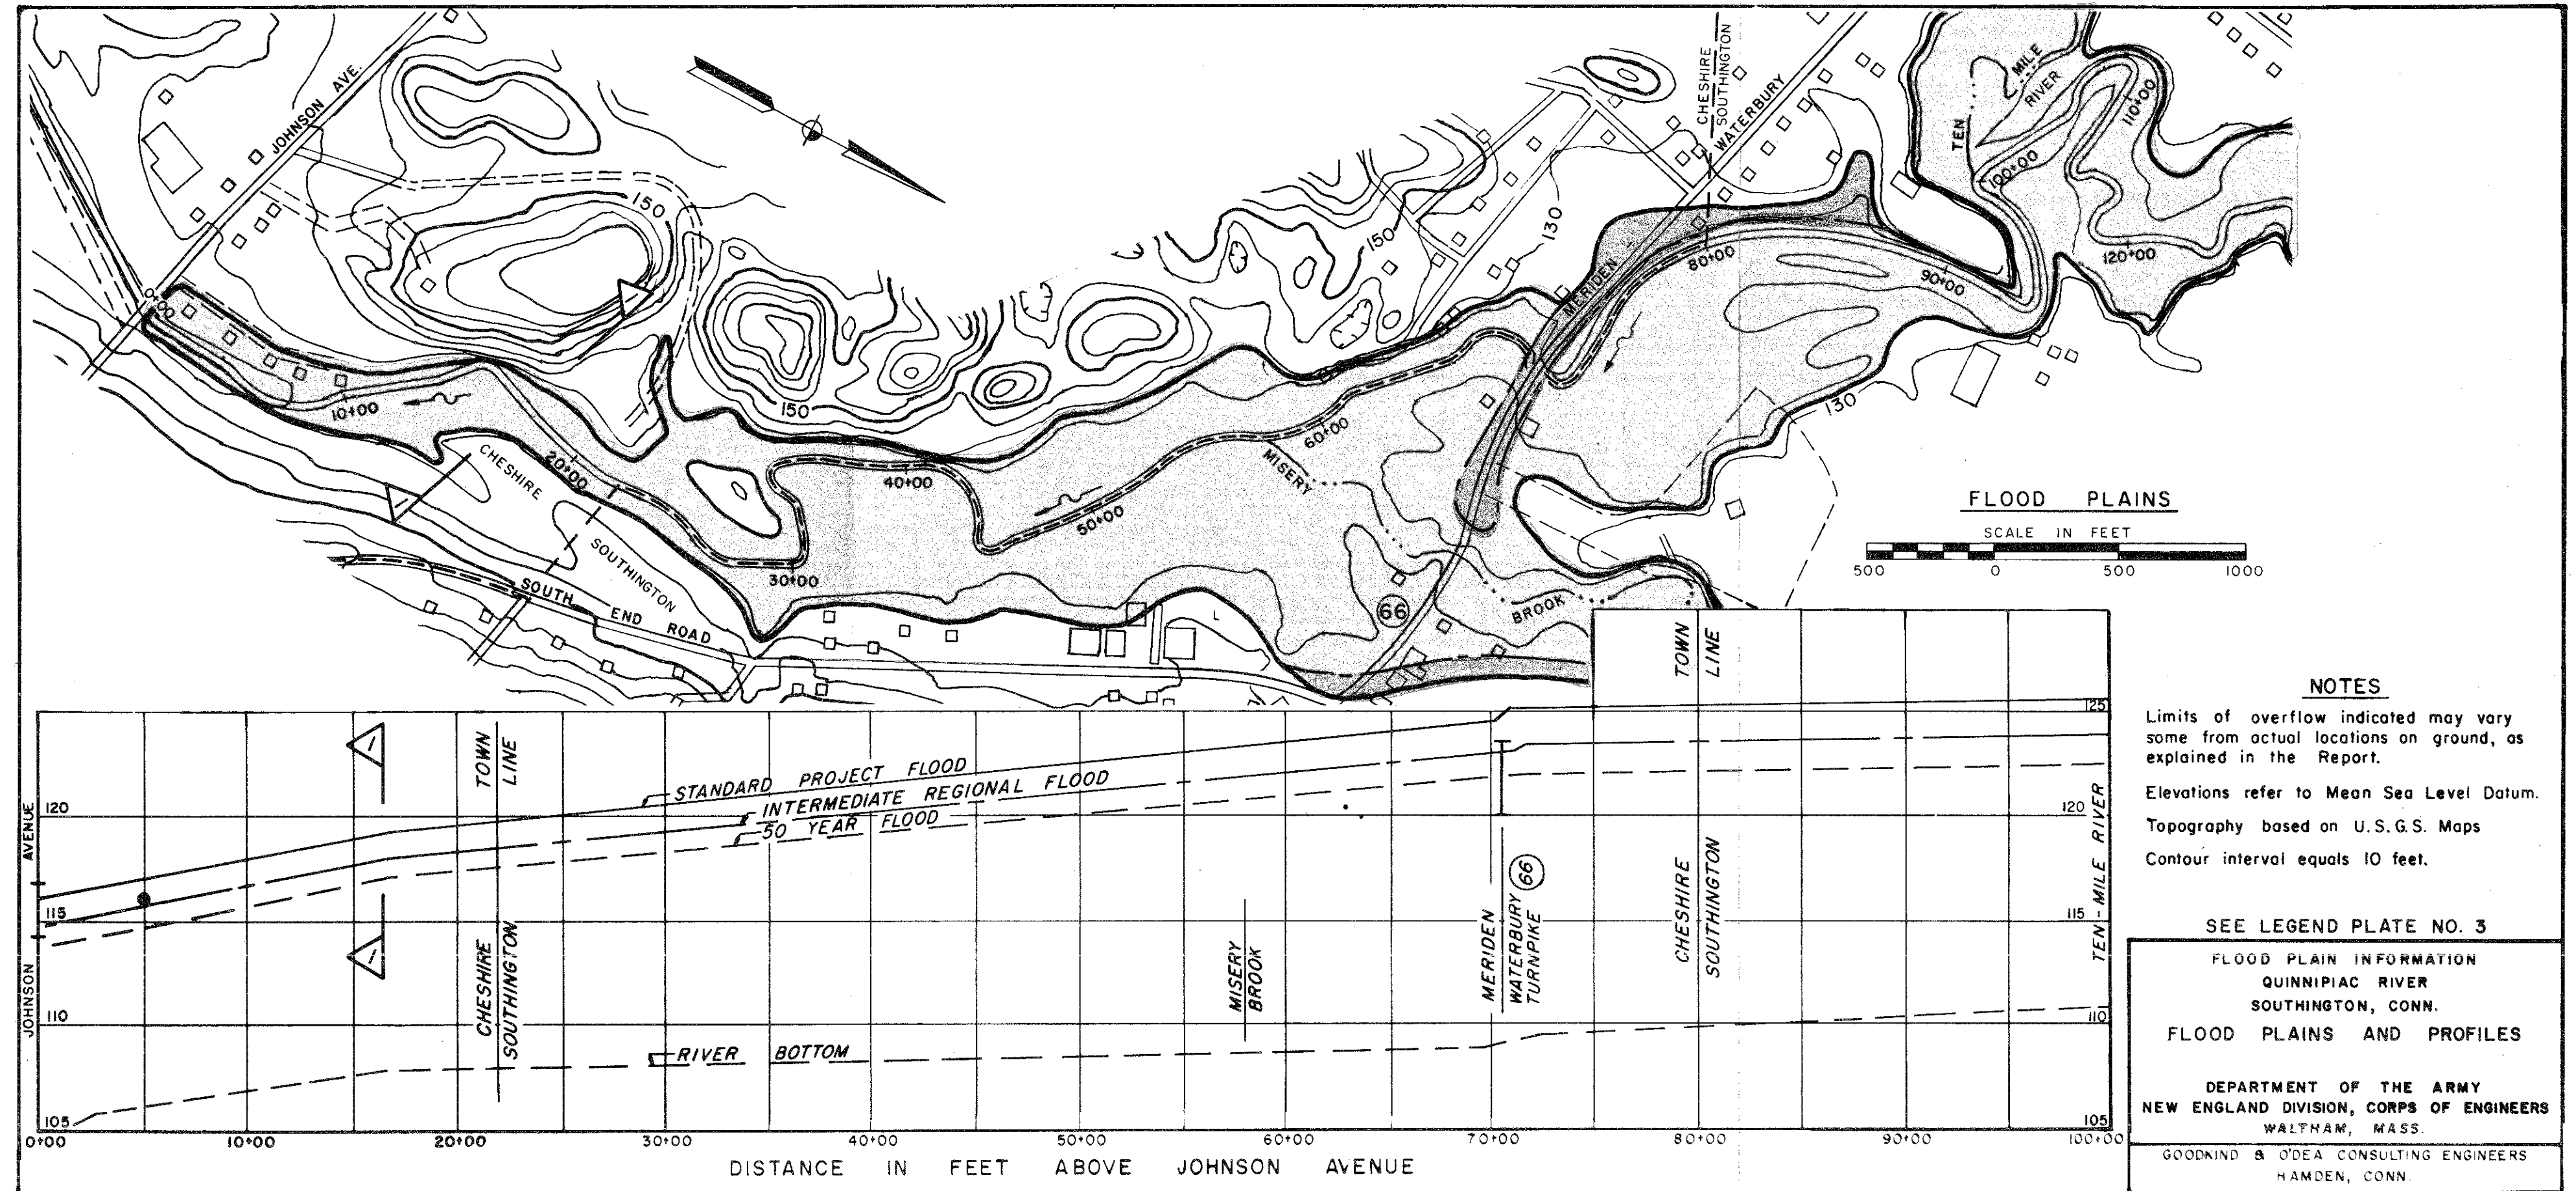
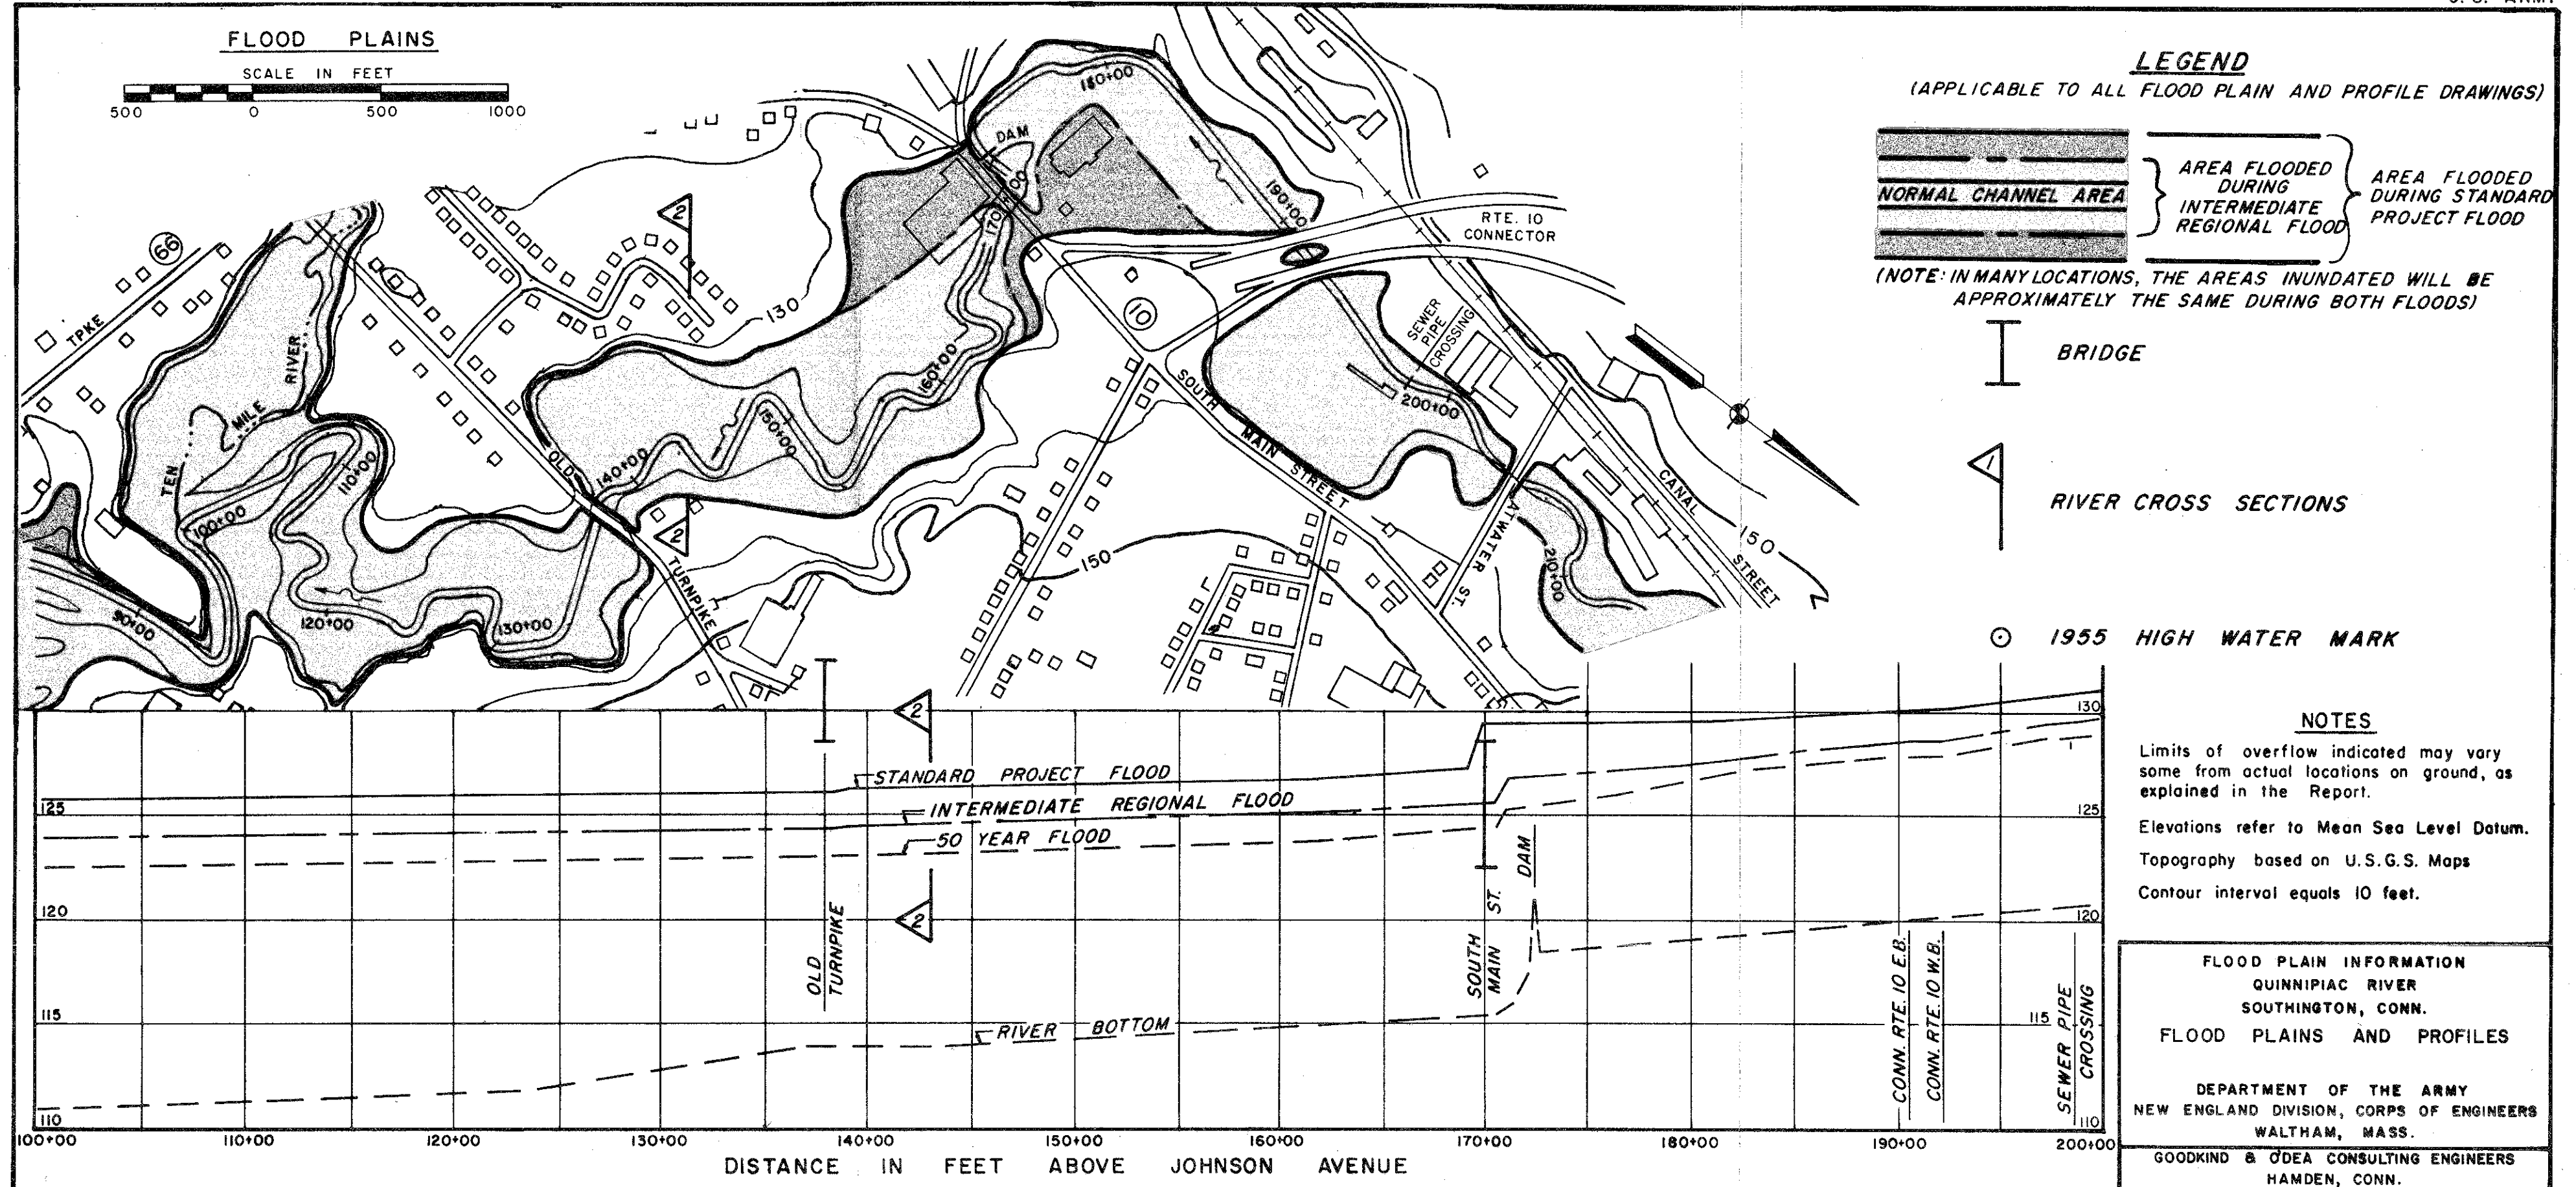
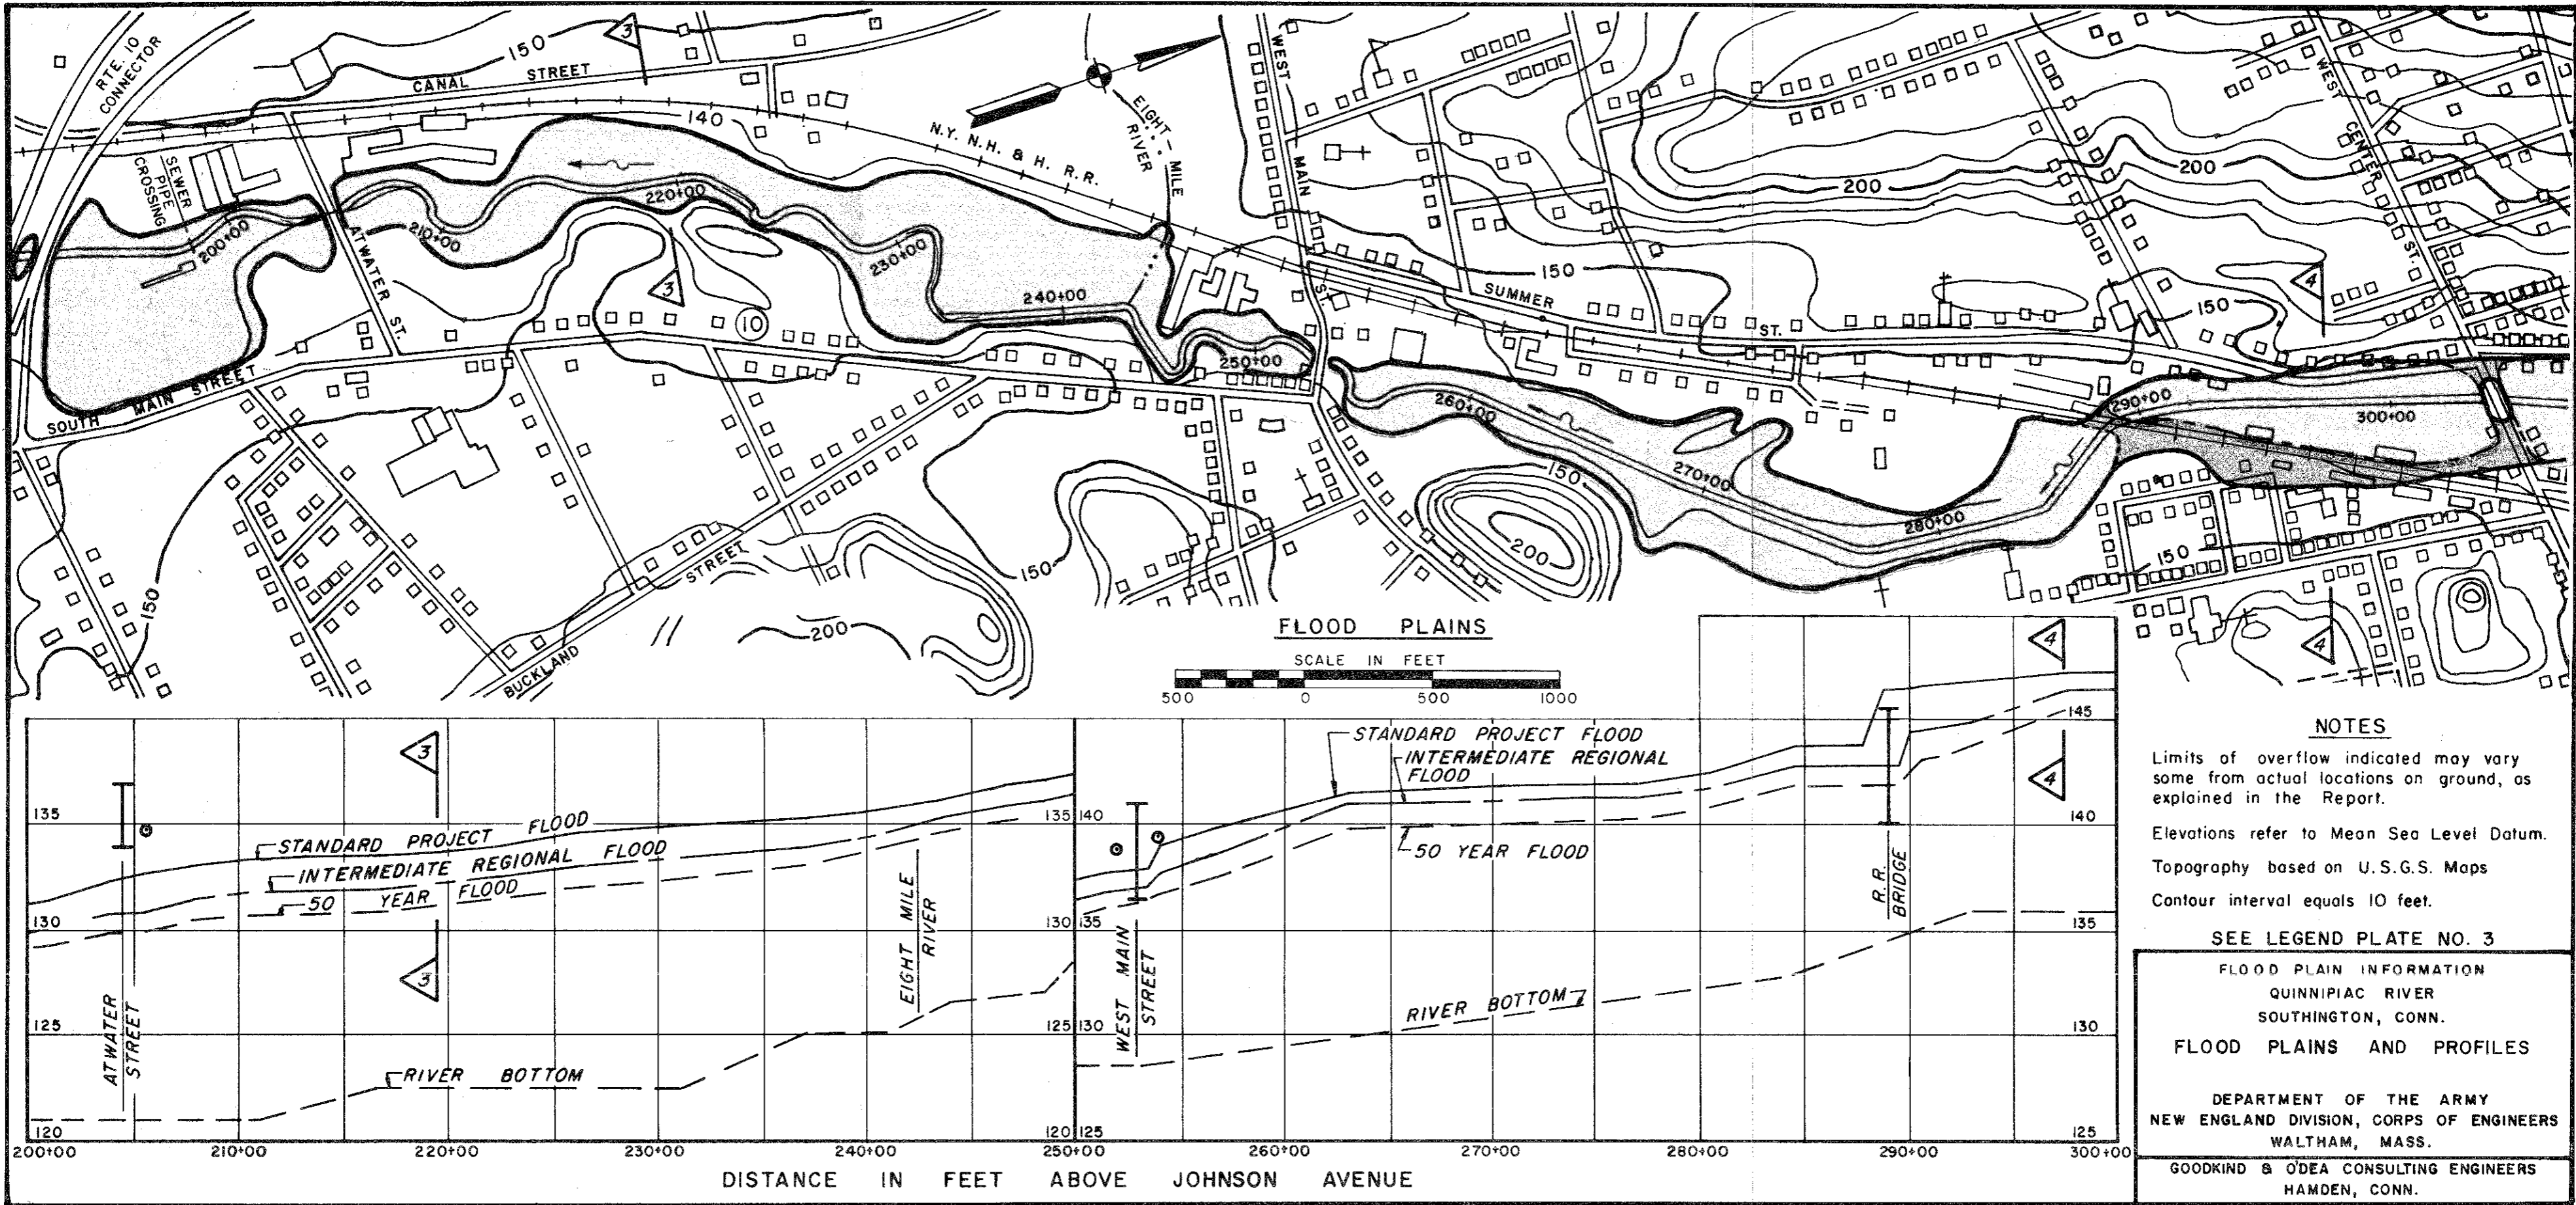
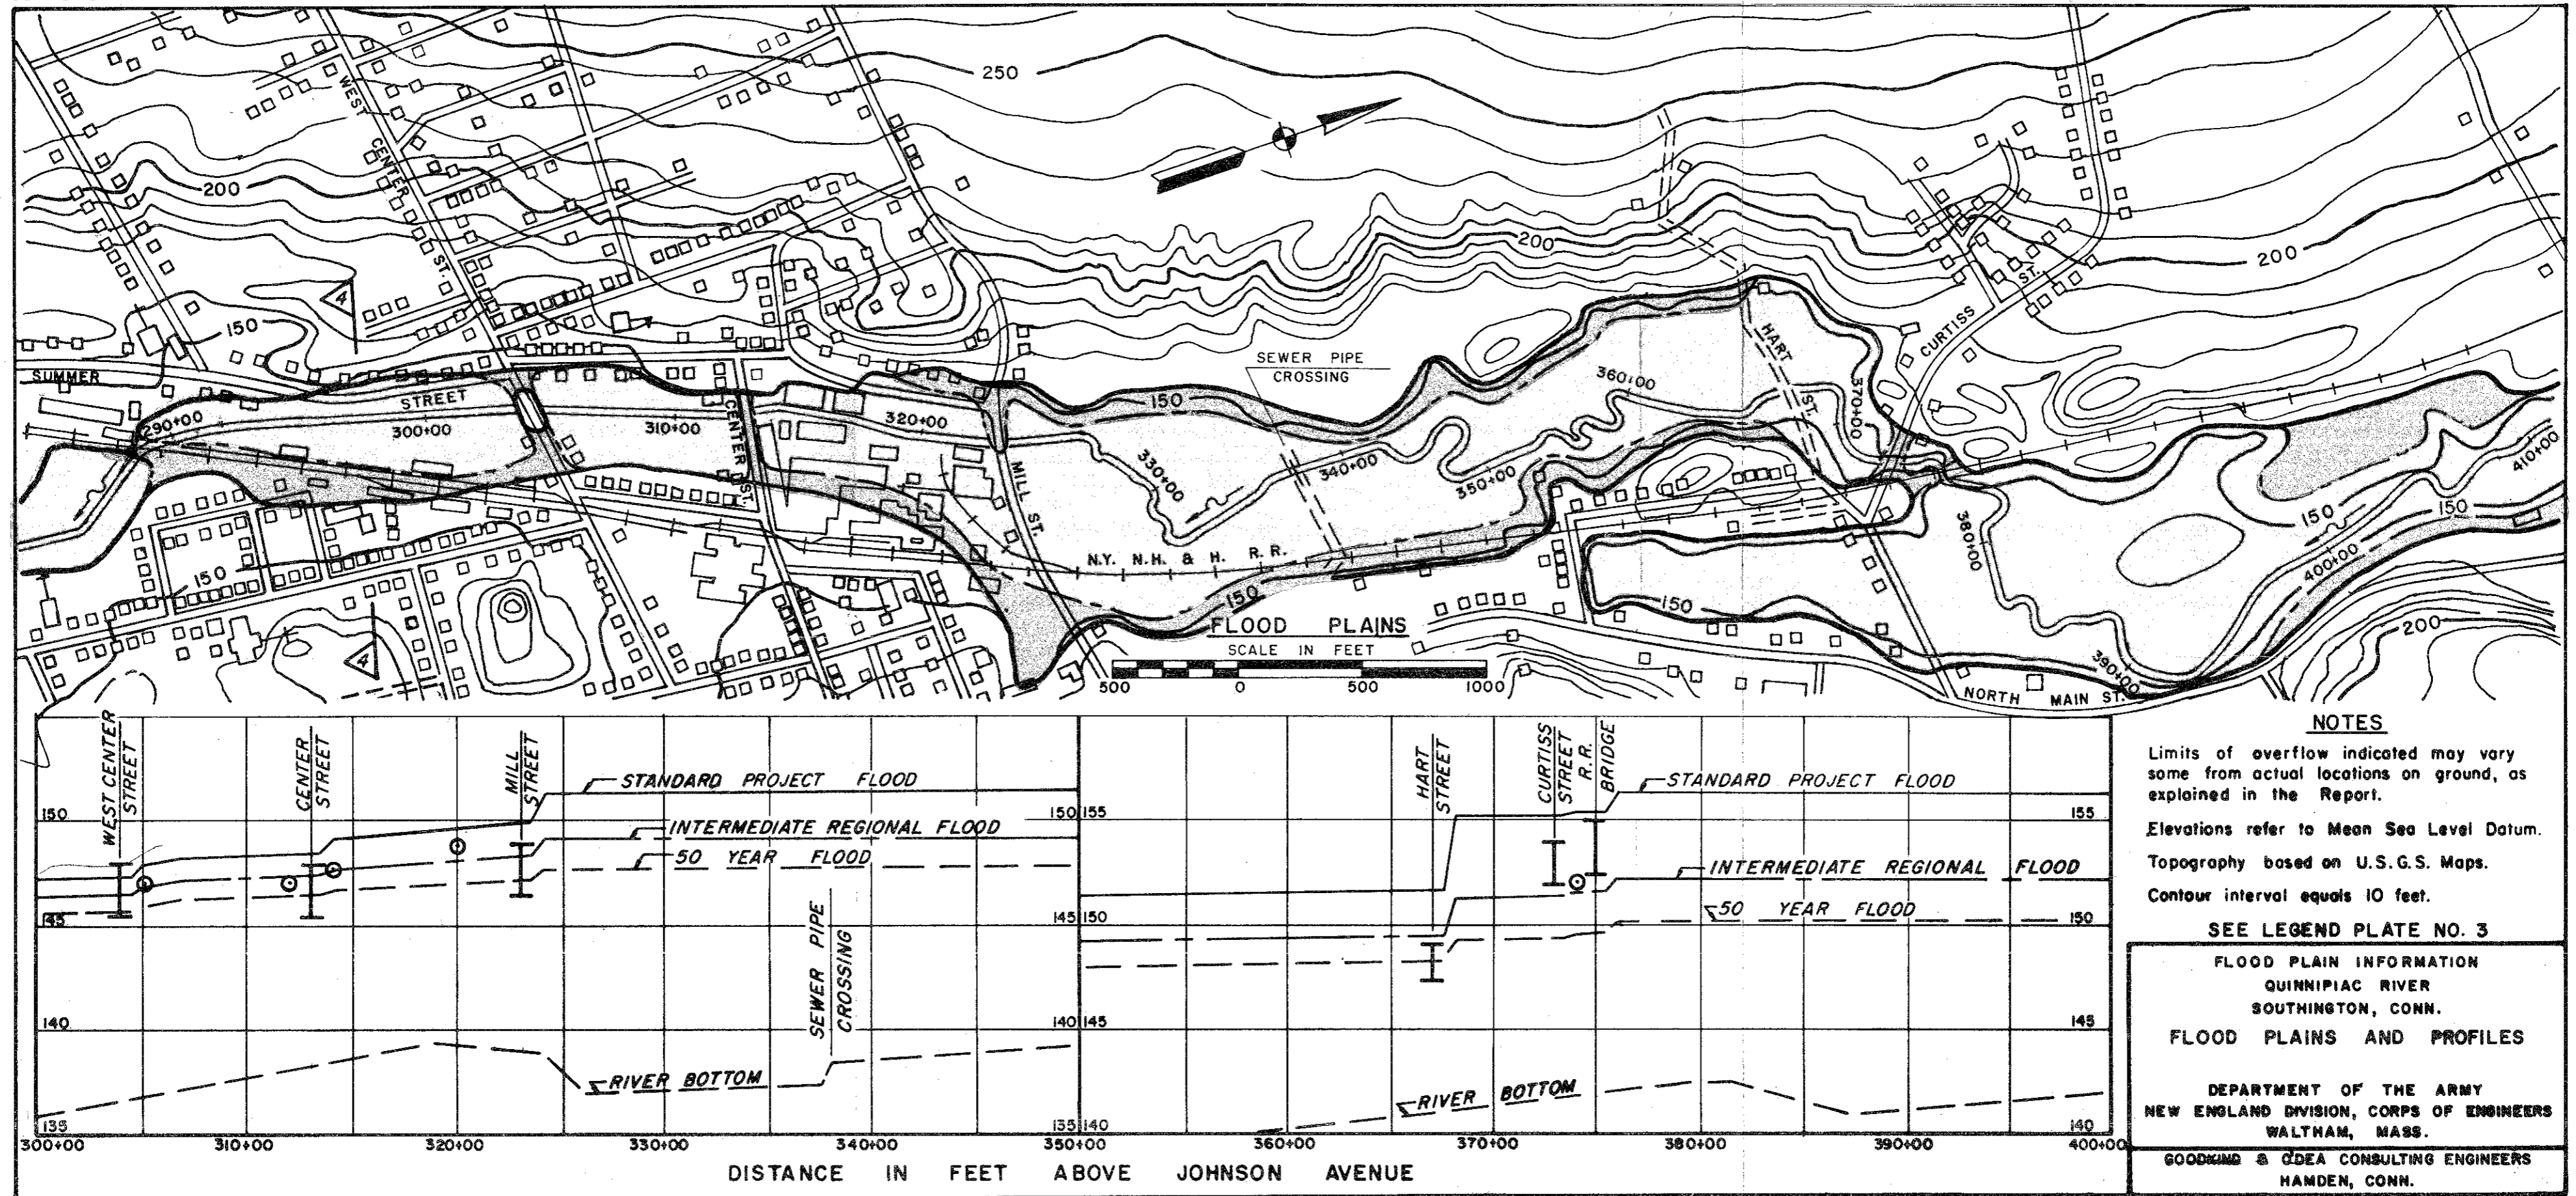
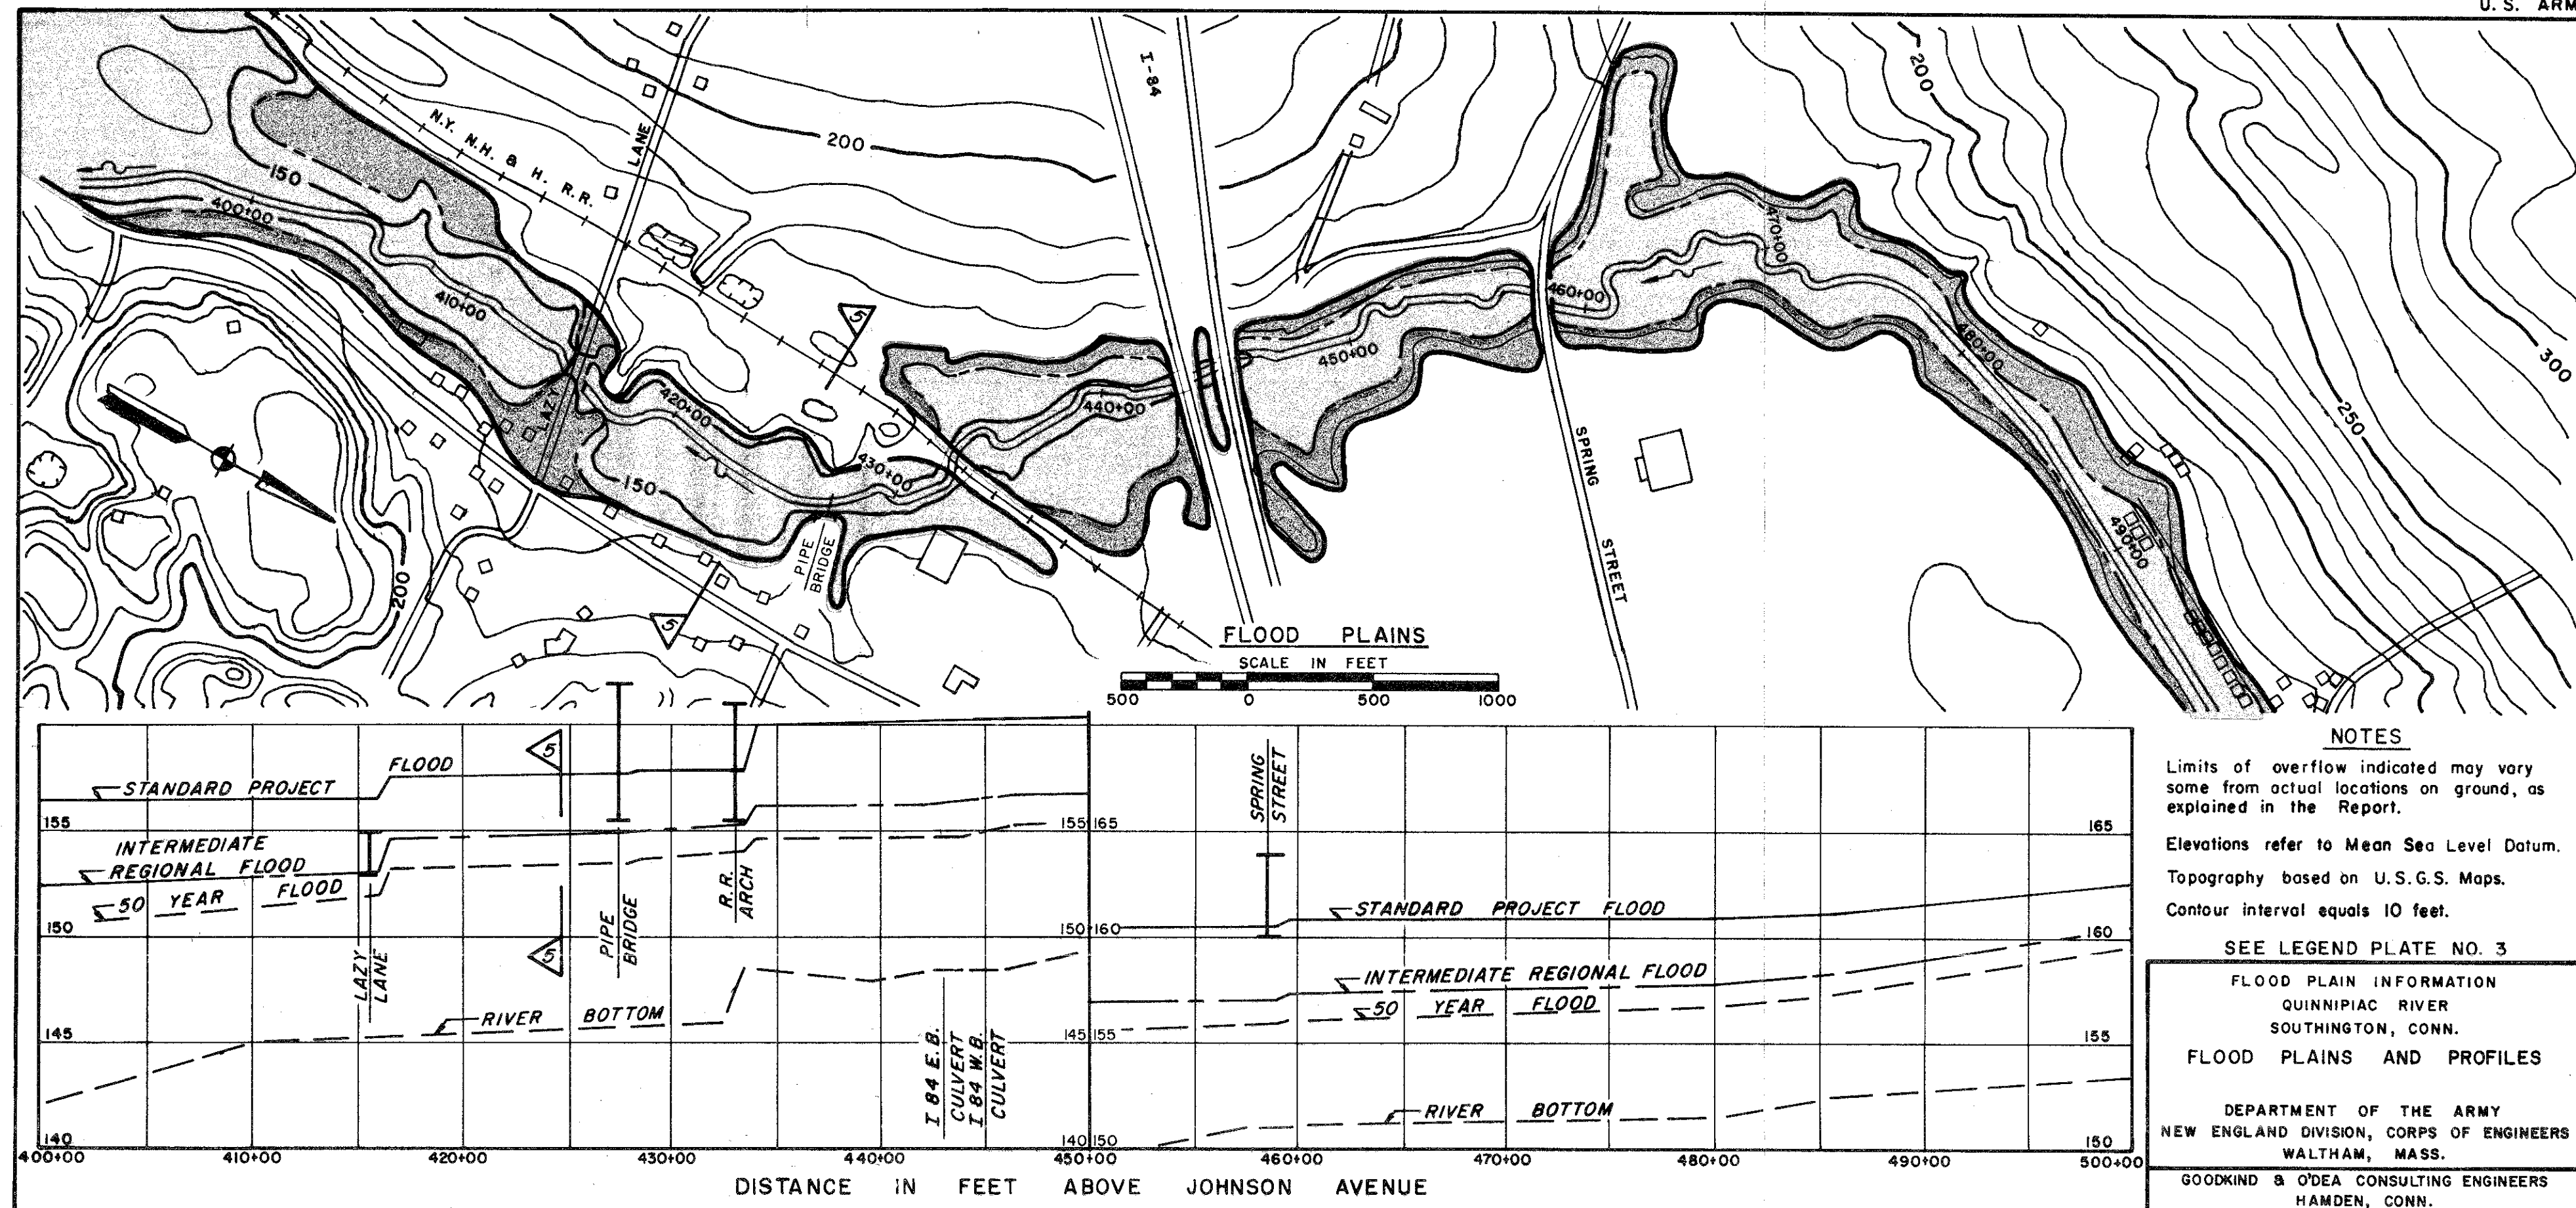
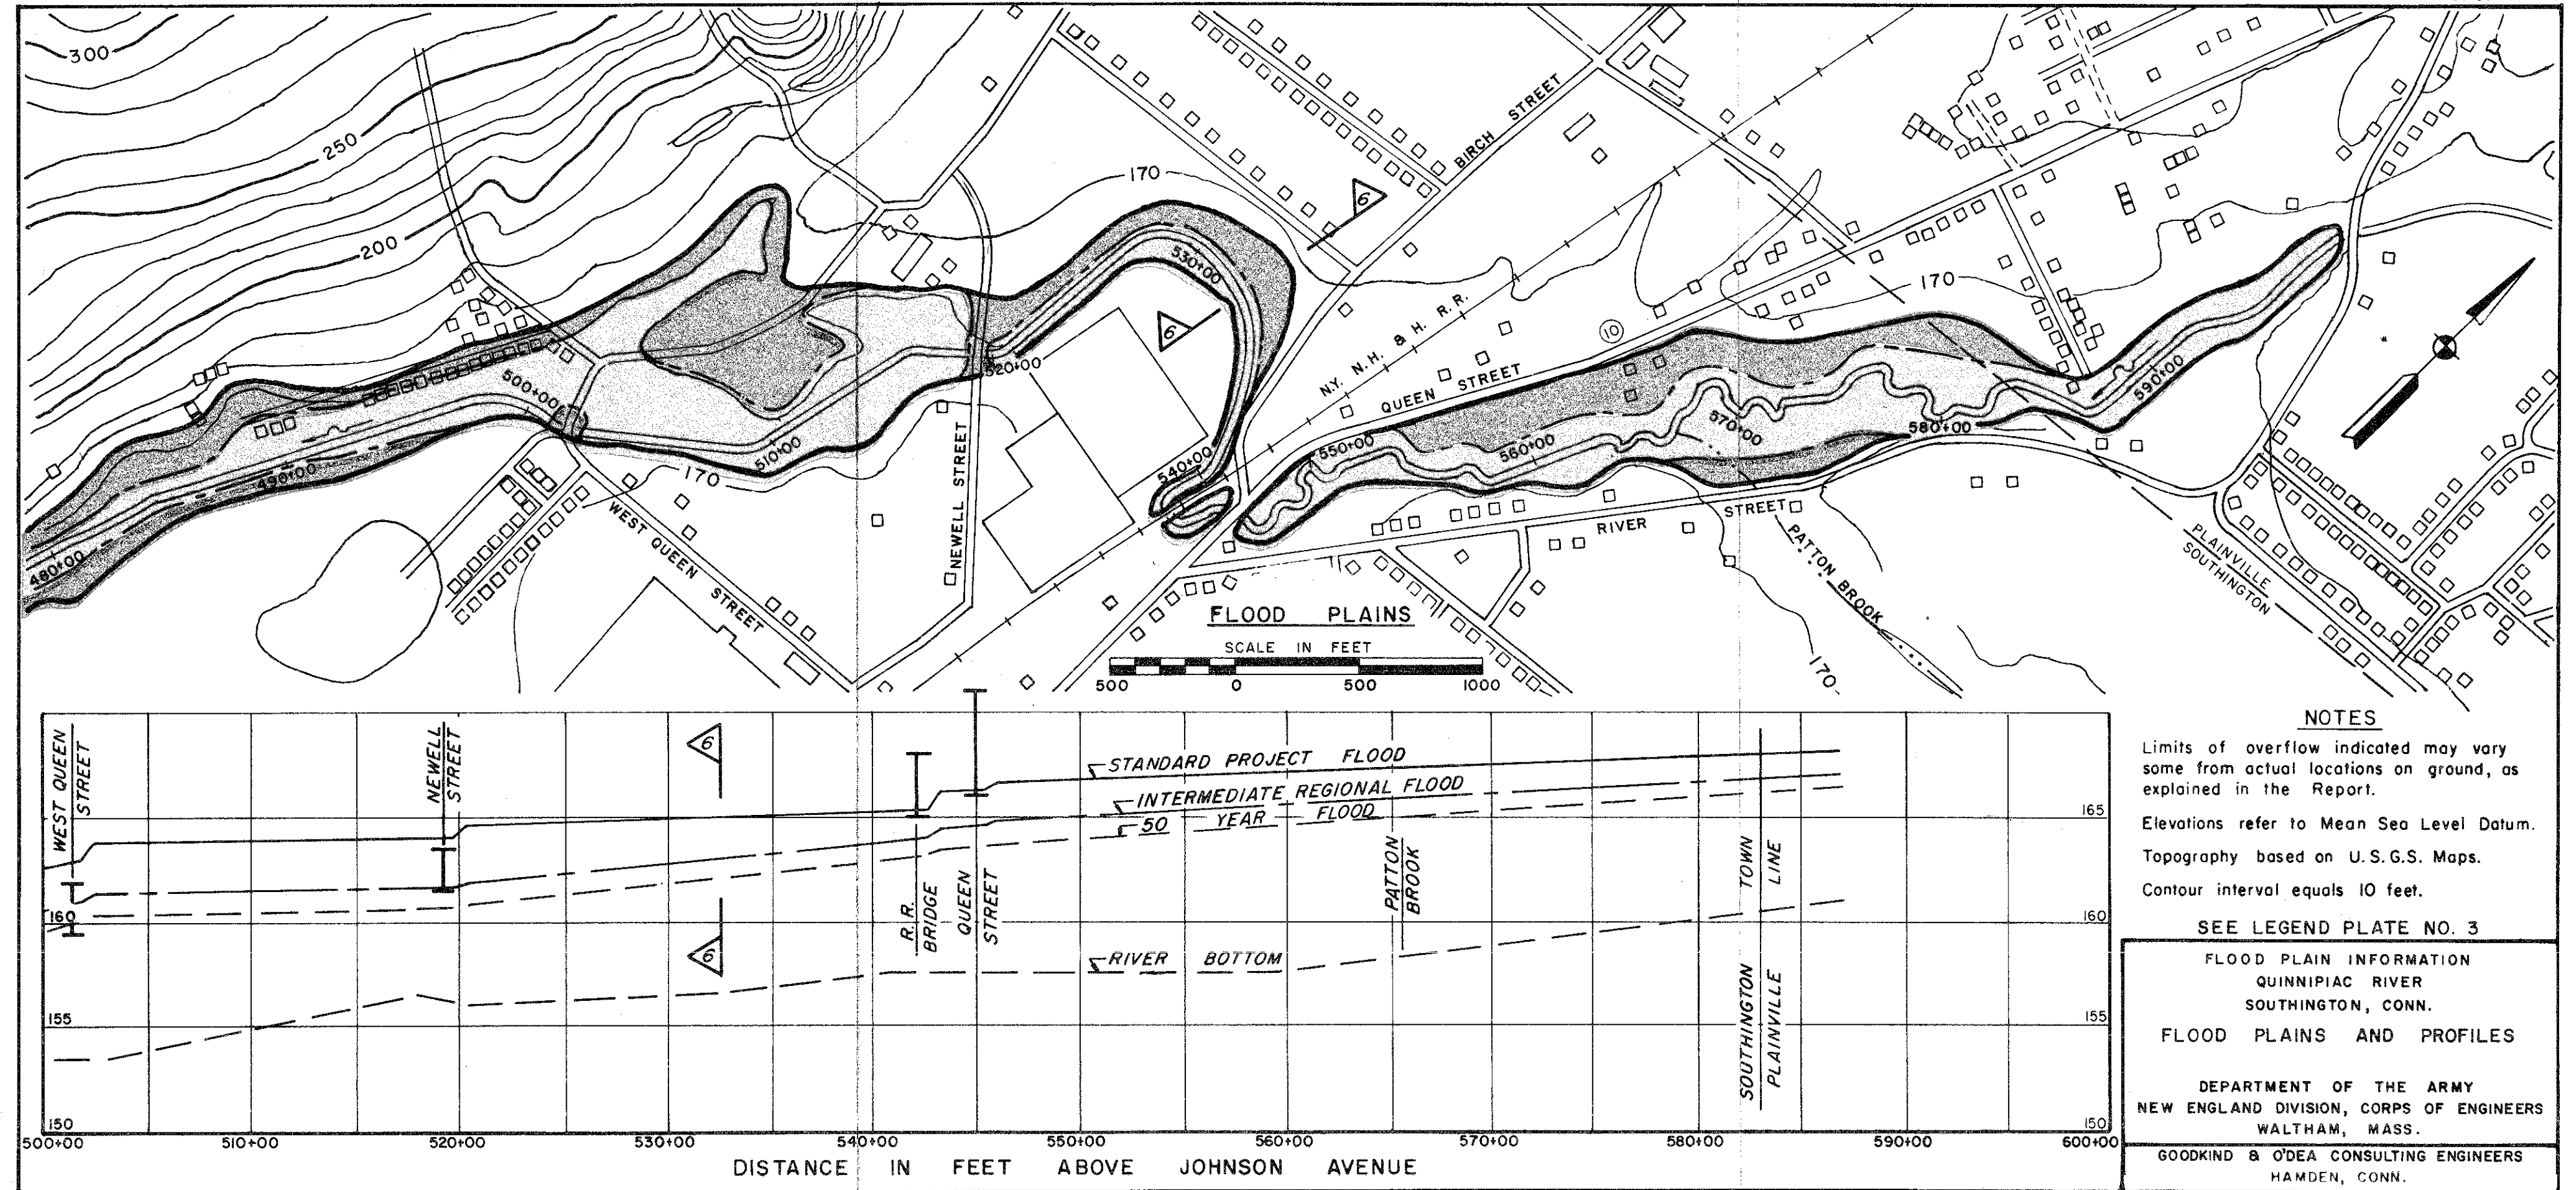
The areas along the Quinnipiac River flooded by the Standard Project Flood and the Intermediate Regional Flood are shown on Plates 2 through 7. Depth of flow can be determined from the profiles which are shown on the same plates.

It should be noted that the limits of inundation indicated on plates 2 thru 7 are only approximate but are consistent with the purposes of this study and the accuracy of the basic data used herein. Standard survey methods can be utilized to determine the depth of flooding at any location along the River with the information shown on the Flood Plain and Profile drawings.

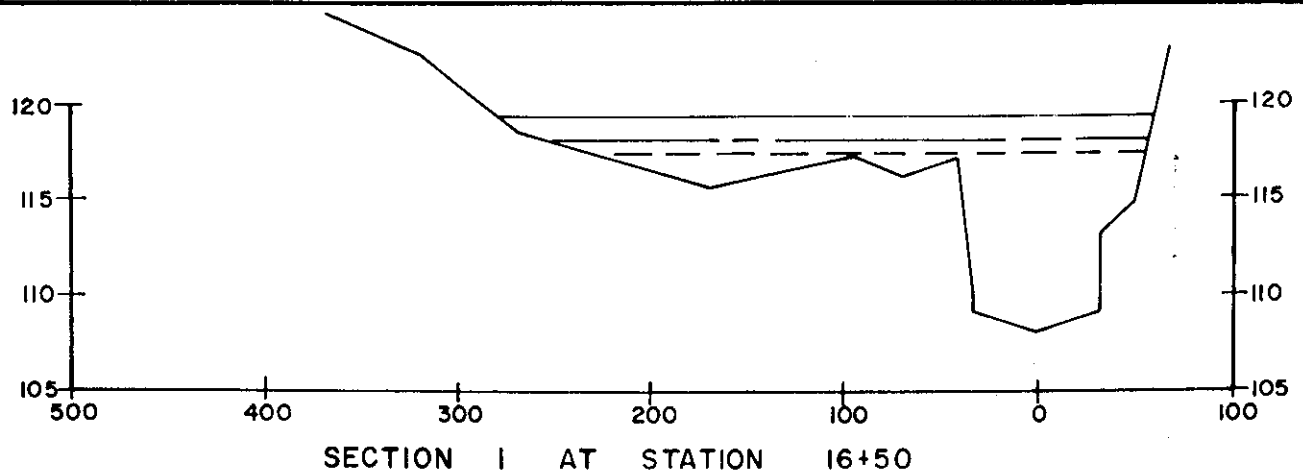
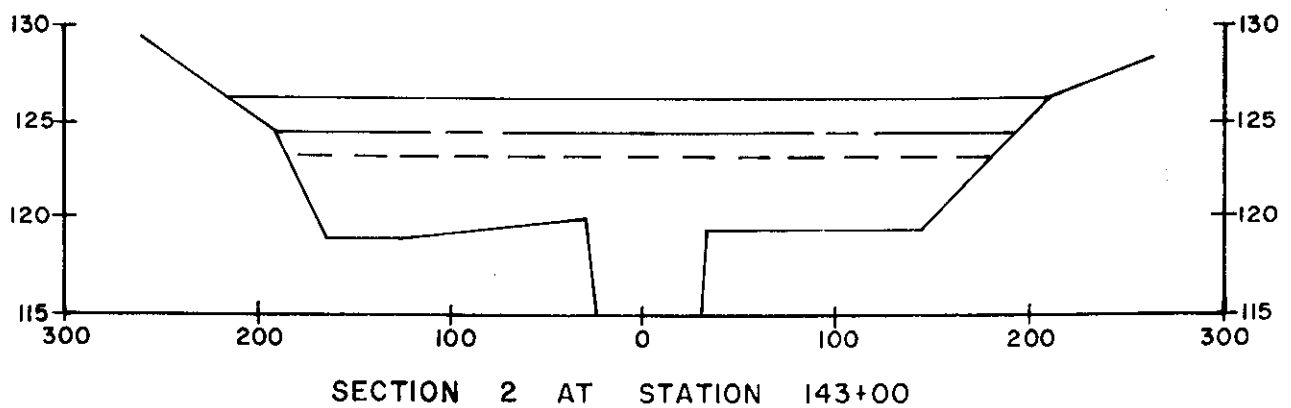
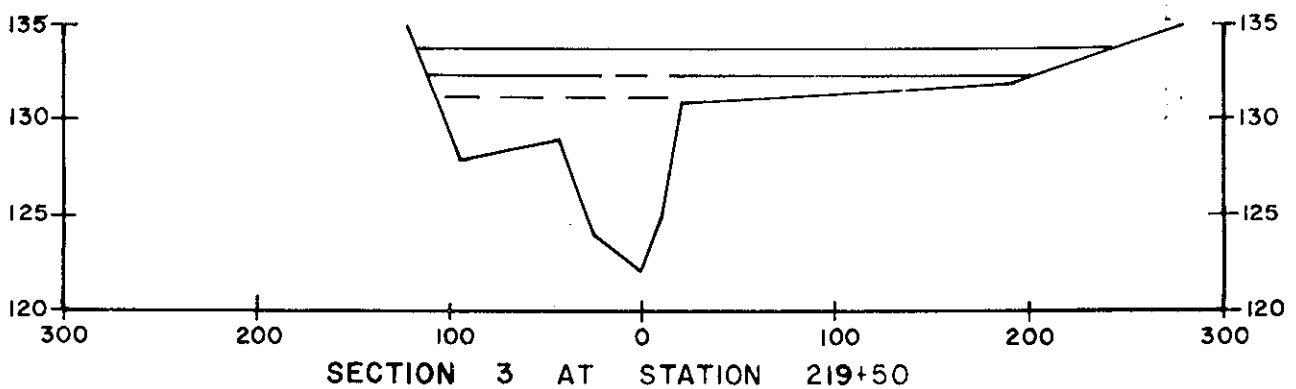
TYPICAL CROSS SECTIONS

Sections taken looking downstream
Horizontal distances and elevations
in feet (Mean Sea Level Datum)

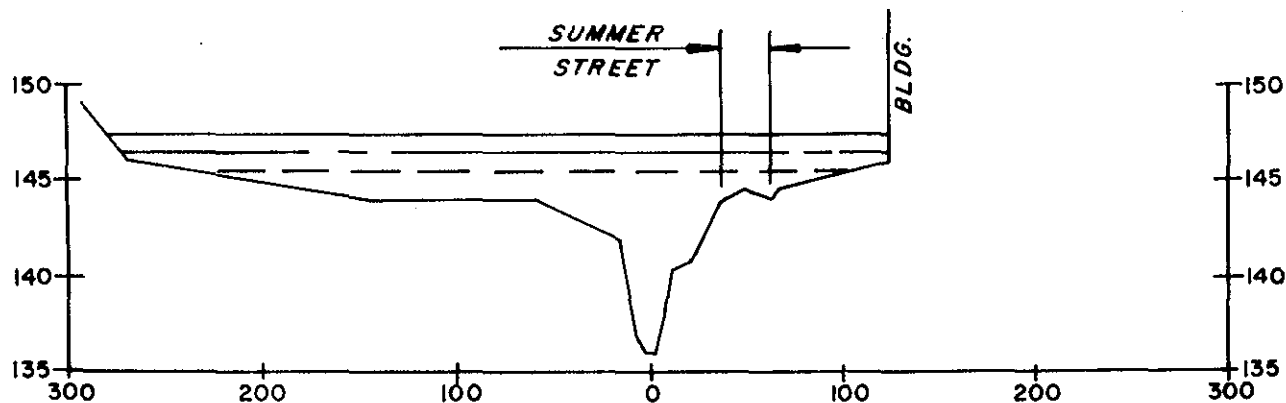
SECTION 4 AT STATION 297+50

Sections taken looking downstream
Horizontal distances and elevations
in feet (Mean Sea Level Datum)
